ARMY MOBILITY EQUIPMENT RESEARCH AND DEVELOPMENT COMM--ETC F/G 17/5
INFRARED MOTION SENSOR EVALUATION, (U)
MAR 78 W C GARRETT
MERADCOM-2237

14 MERADCOM -
Report 2237

6 INFRARED MOTION SENSOR EVALUATION,

U.S. ARMY MOBILITY EQUIPMENT
RESEARCH AND DEVELOPMENT COMMAND
FORT BELVOIR, VIRGINIA

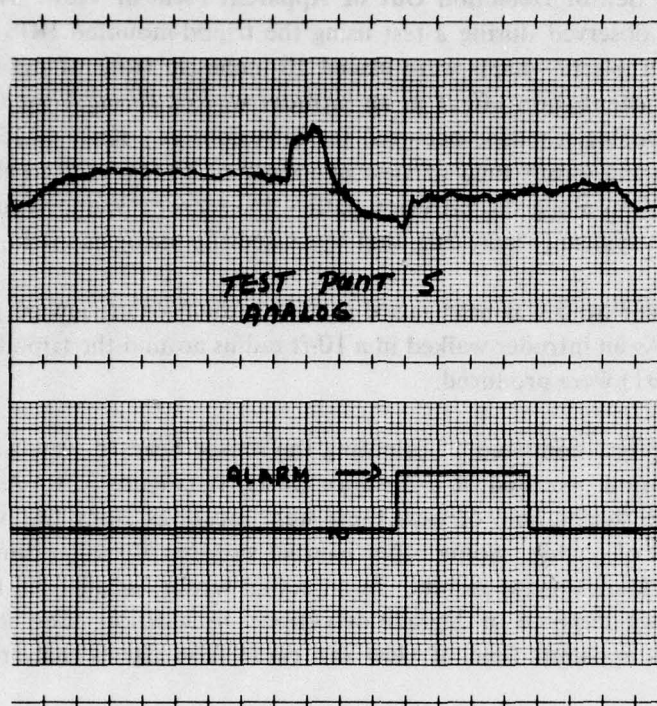
1. Detector field of view facing ceiling mounted duct constructed of galvanized sheet steel.
2. Detector mounted 6' high and intruder moving on 10' radius around detector.

Figure 31. IRIS analog response (duct reflection) for intrusions out of the apparent field of view.

12. Infrared Sensor Detection Out of Apparent Field of View. An interesting phenomenon was observed during a test using the tripod-mounted IRIS sensor head. Plexiglas and other plastic sheets were placed 18 inches in front of the sensor optics to determine the attenuation effect as an intruder walked through the field of view. For plexiglas, no analog response occurred for intrusions at a range of 15 ft. Another individual crossing the sensor field of view at a range of 28 ft produced alarm levels of analog at one location along the intrusion path – the sensor responded to a reflection, off the ceiling duct system (Figure 20), that by-passed the plexiglas shield.
